U.S. ARMY CORPS OF ENGINEERS
NEW ENGLAND DISTRICT

WARWICK COVE
WARWICK, RHODE ISLAND
CONDITION SURVEY

6-FOOT CHANNEL AND ANCHORAGES

Sheet 1 of 4

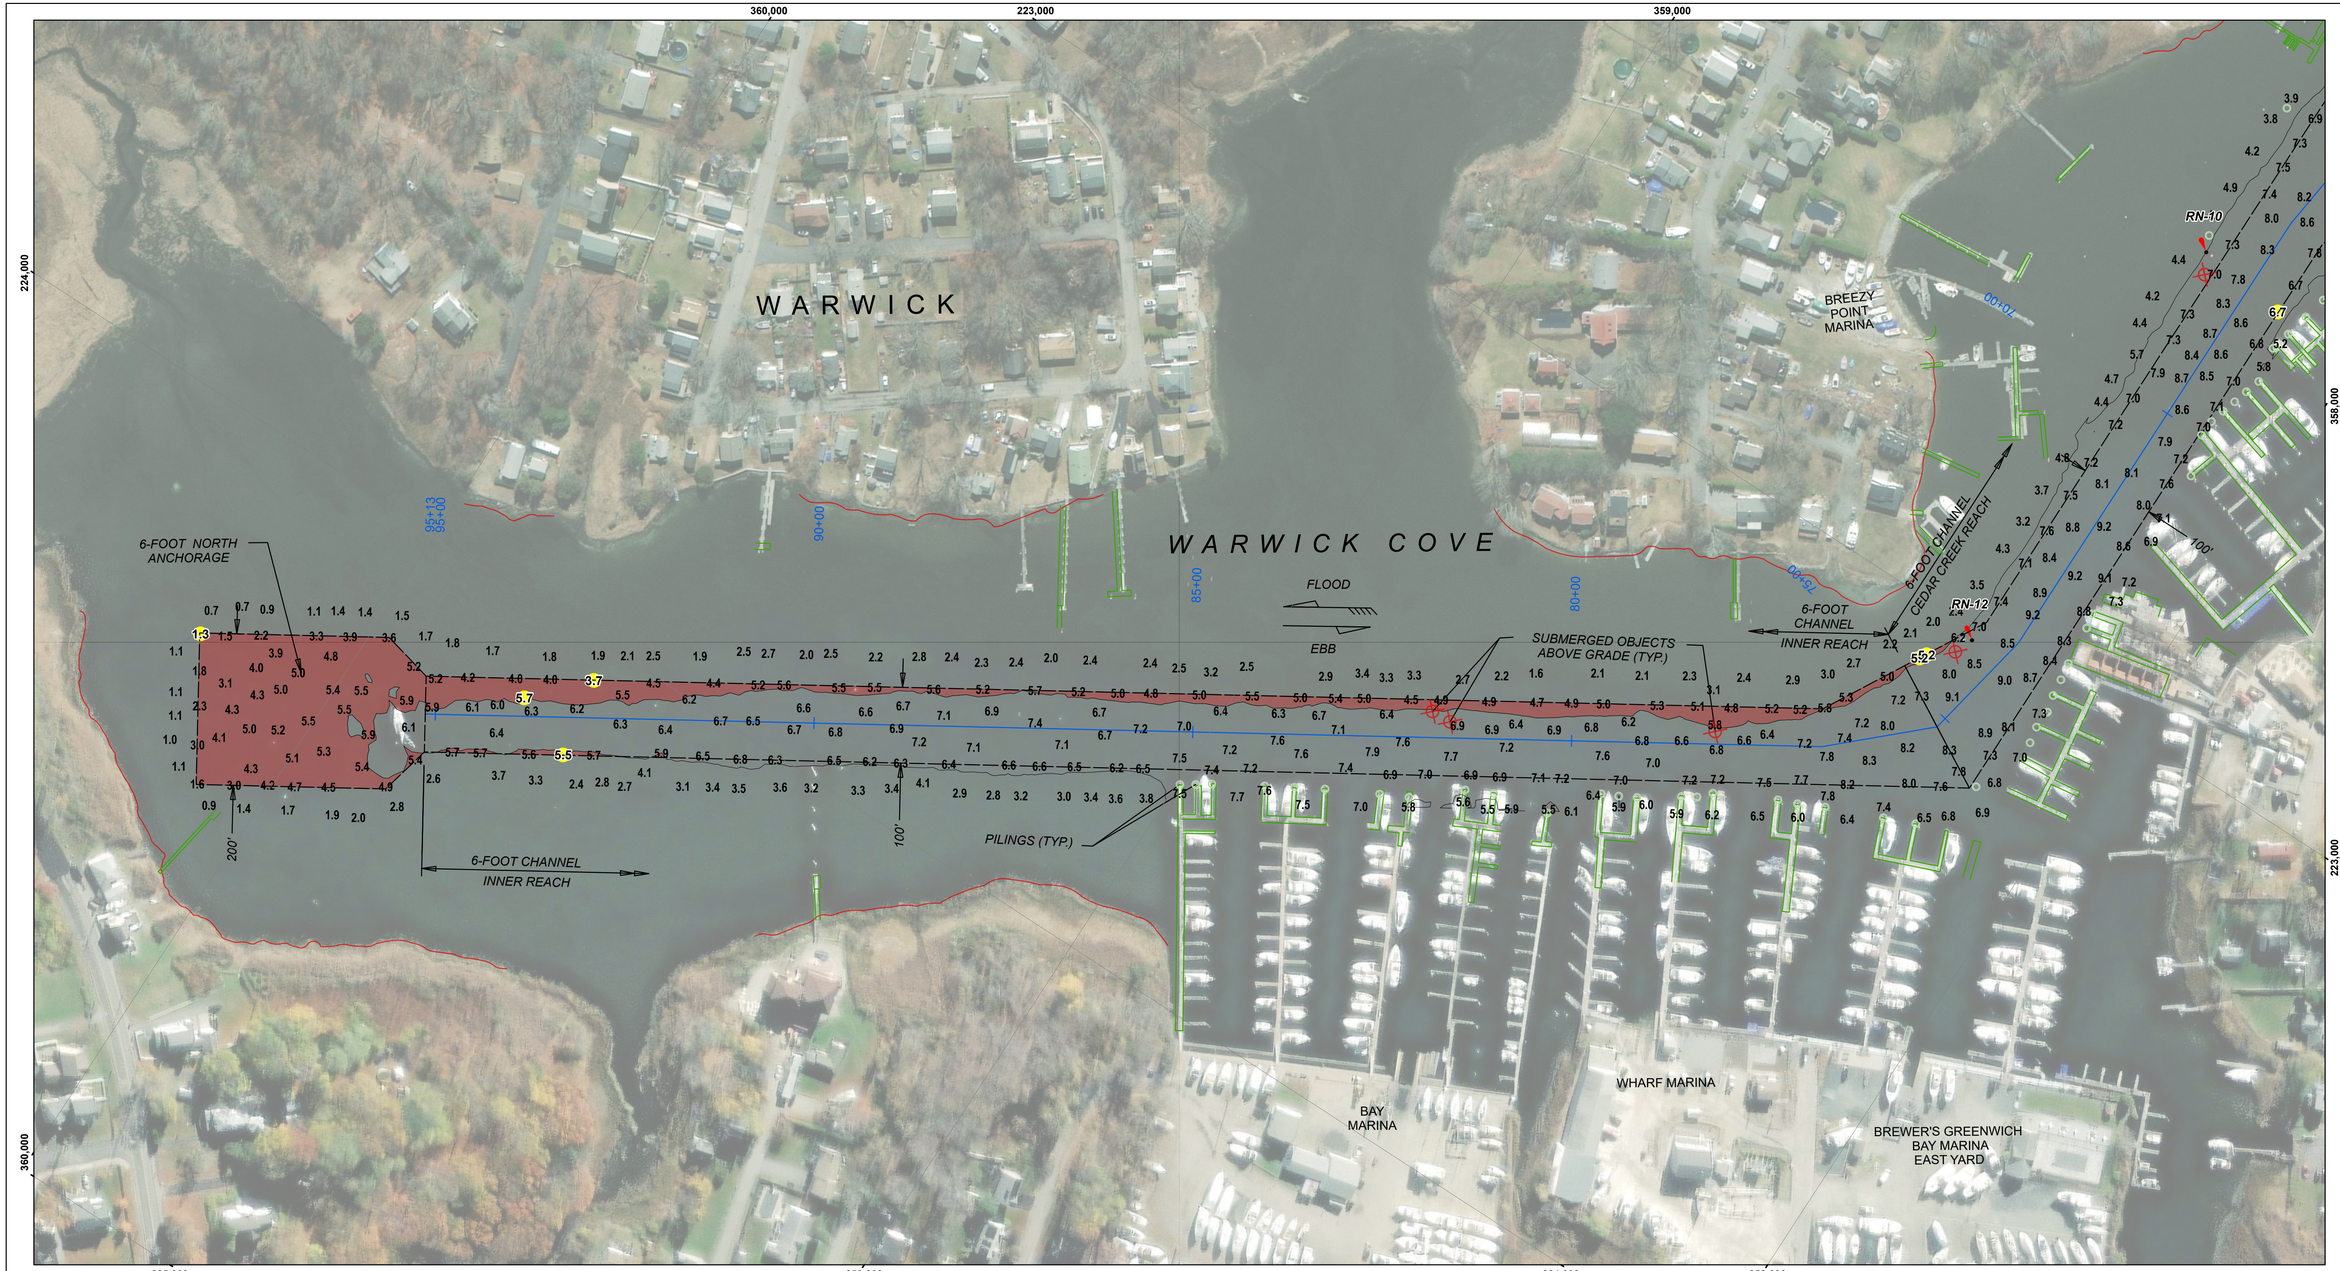
SHEET IDENTIFICATION
Warwick Cove
Sheet 3 of 4

WARWICK
WARWICK NECK
WARWICK COVE
MARINA WINSTEADS
PILINGS (TYP.)
FLOOD
EBB
SUBMERGED CHAINS THROUGHOUT 6-FOOT EAST ANCHORAGE AND CHANNEL
SUBMERGED OBJECT BELOW GRADE (TYP.)
SUBMERGED BOAT ABOVE GRADE
6-FOOT EAST ANCHORAGE
DEBRIS AT OR NEAR GRADE
SUBMERGED BOAT BELOW GRADE
BREEZY POINT MARINA
RN-10
RN-12
GC-9
6-FOOT CHANNEL INNER REACH
6-FOOT CHANNEL CEDAR CREEK REACH
6-FOOT CHANNEL WARWICK COVE REACH
6-FOOT WEST ANCHORAGE
SUBMERGED OBJECT ABOVE GRADE (TYP.)
SUBMERGED BOAT ABOVE GRADE
BREWER GREENWICH BAY MARINA
SECOND POINT
CEDAR CREEK
PLEASURE MARINA
50+00
55+00
60+00
65+00
70+00
75+00
100'
300'
